CASE-001: Performance of an 8 Year Old Competition Track at an NCAA Div-I University

ASET Services, Inc was hired to determine the force reduction and thickness of an 8 year old competitive running track at a NCAA Division I University. The goal of the project was to provide the university with the current status of their track so that they could determine if the track could simply be repainted or if it needed to be resurfaced to restore performance to the original IAAF required and specified levels.

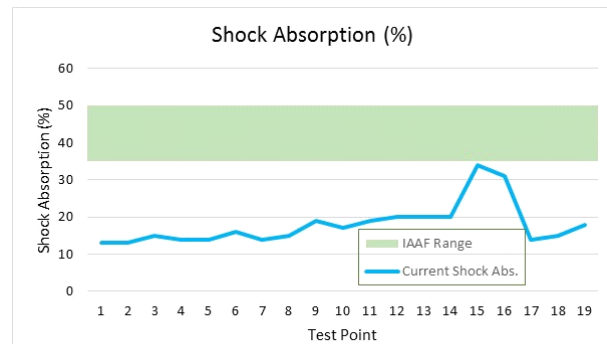
Illustration 2: Shock Absorption by Test Point

The following illustration contains the shock absorption readings recorded from 19 test points. Only two point produced shock absorption levels above 30%. The average shock absorption was 18%. IAAF requires a minimum shock absorption of 35%, which is shown in the green shaded region of the illustration. No point exceeded 35%.

The lowest shock absorption level recorded was 13%, which was produced at two locations. Another four test points produced a shock absorption of only 14%.

The track should produce a shock absorption level of no less than 35%, per IAAF Rules. The track produced an average shock absorption level of only 18%. This means that during the 8 years of use the shock absorption has been reduced by at least 17% on average. The lowest shock absorption reading was 13%, meaning that these areas of the track were now 22% below the minimum level required by the IAAF.

The track has lost a substantial amount of material and would need to be resurfaced (more rubber material added) in order to comply with IAAF's minimum requirements. Painting the surface will not bring the track back into compliance for IAAF certification.

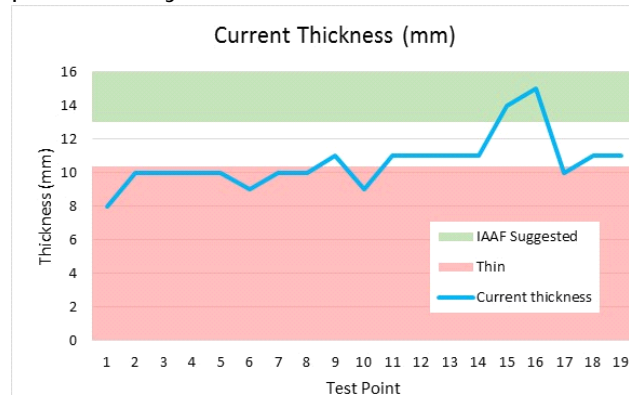
Illustration 3: Thickness Readings by Test Point

The following illustration contains the thickness readings from 19 test points on the track. The region in red meets the requirements for 'Exceptionally Thin' per the IAAF specifications. Three of the 19 test points are below 10.4 mm and clearly qualify as exceptionally thin. Another 13 test points were recorded at 10.0 or 11.0 mm, his places them within the definition of exceptionally thin, or so close to it that they cannot be excluded from it. Only 2 of the 19 test points were thick enough that they met or barely exceeded the thickness guidelines published by IAAF.

The average thickness over the entire track was 10.6 mm, meaning that on average, the track had lost 2.4 mm of material on average. The lowest thickness recorded was 9 mm, and two locations produced that reading.

The track should have been installed to a thickness no less than the 13 mm that was used during lab testing. This means that during the 8 years that the track has been in service, the surface has lost, at least 2.4 mm of material on average. The lowest thickness measured was 9 mm, meaning that the track should have lost at least 13 mm, if IAAF installation guidelines had been followed.
