CASE-004: 10 Year old Hardwood Court Shows Significant Deterioration

By: Paul W Elliott, PhD, PE, CPSI

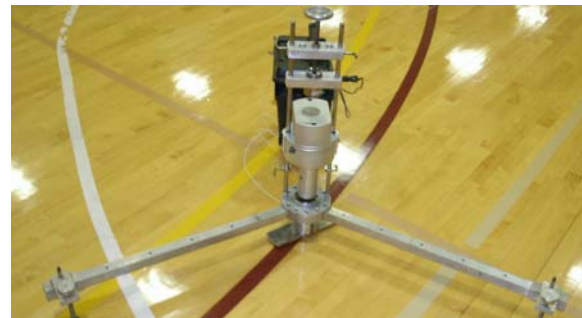
MFMA PUR standards. The force reduction equipment is shown in Illustration 1.

Illustration 1: Shock Absorption and Thickness Test Equipment

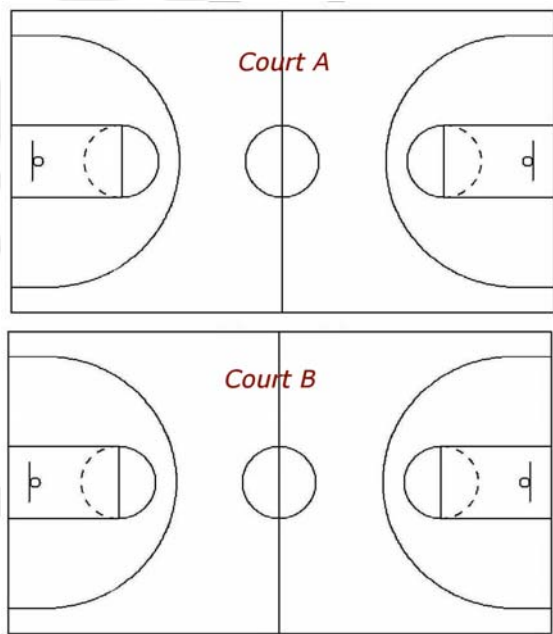
were side-by-side. They are labeled the 'Court A' and 'Court B' in Illustration 3. The remainder of the article will use this reference.

ASET was told by the staff that Court B was used more frequently than the Court A, with estimates that the Court B could see between 200% and 300% more use than the Court A.

Illustration 2: Facility Layout

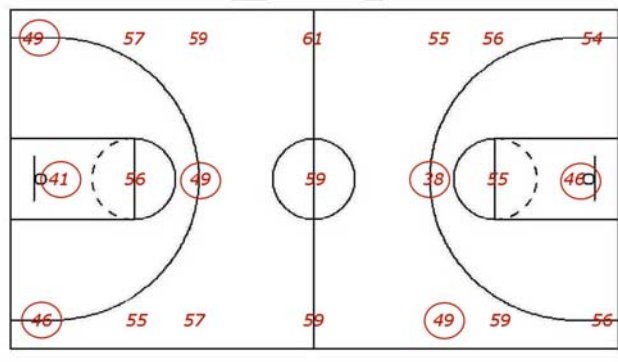
Court B Force Reduction Results						
49	57	59	61	55	56	54
41	56	49	59	38	55	46
46	55	57	59	49	59	56

Illustration 3: Force Reduction Map of Court B

- Average = 53%
- Max = 63%
- Min = 38%
- Range = 25%
- Standard Deviation 6.3%

Seven of the 21 points tested were more than 10% below the maximum value. Two points were more than 20% below the maximum value. The cause of the low force reduction values could not be determined with certainty, but will be further explored later in this document.

- Both courts produced significantly lower force reduction values beneath the baskets and at the top of the 3-point arc.
- Both courts have one end where the force reduction in the two corners on the 3-point line were significantly lower than the rest of the court.

While the cause of the lower force reduction values cannot be pinpointed, ASET believes that they are consistent with use trends prevalent in today's higher-level competitive basketball.

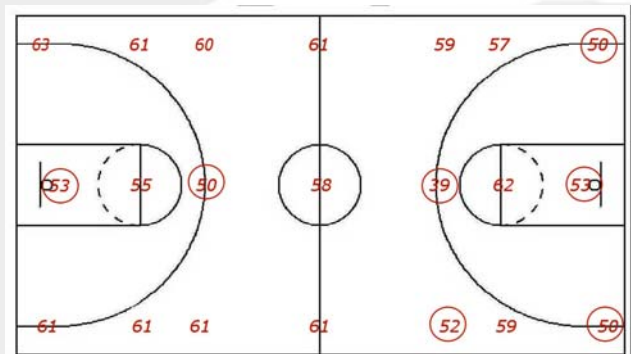
Court A Force Reduction Results						
63	61	60	61	59	57	51
53	55	50	58	39	62	53
61	61	61	61	52	59	50

Illustration 4: Force Reduction Map Of Court A

- Average = 56%
- Max = 63%
- Min = 39%
- Range = 24%
- Standard Deviation 5.9%

Seven of the 21 points tested were more than 10% below the maximum value. One point was more than 20% below the maximum value. The cause of the low force reduction values could not be determined with certainty, but will be further explored later in this document.
